First Five-Year Review Report

Taylor Road Landfill

Hillsborough County, Florida

September, 2003

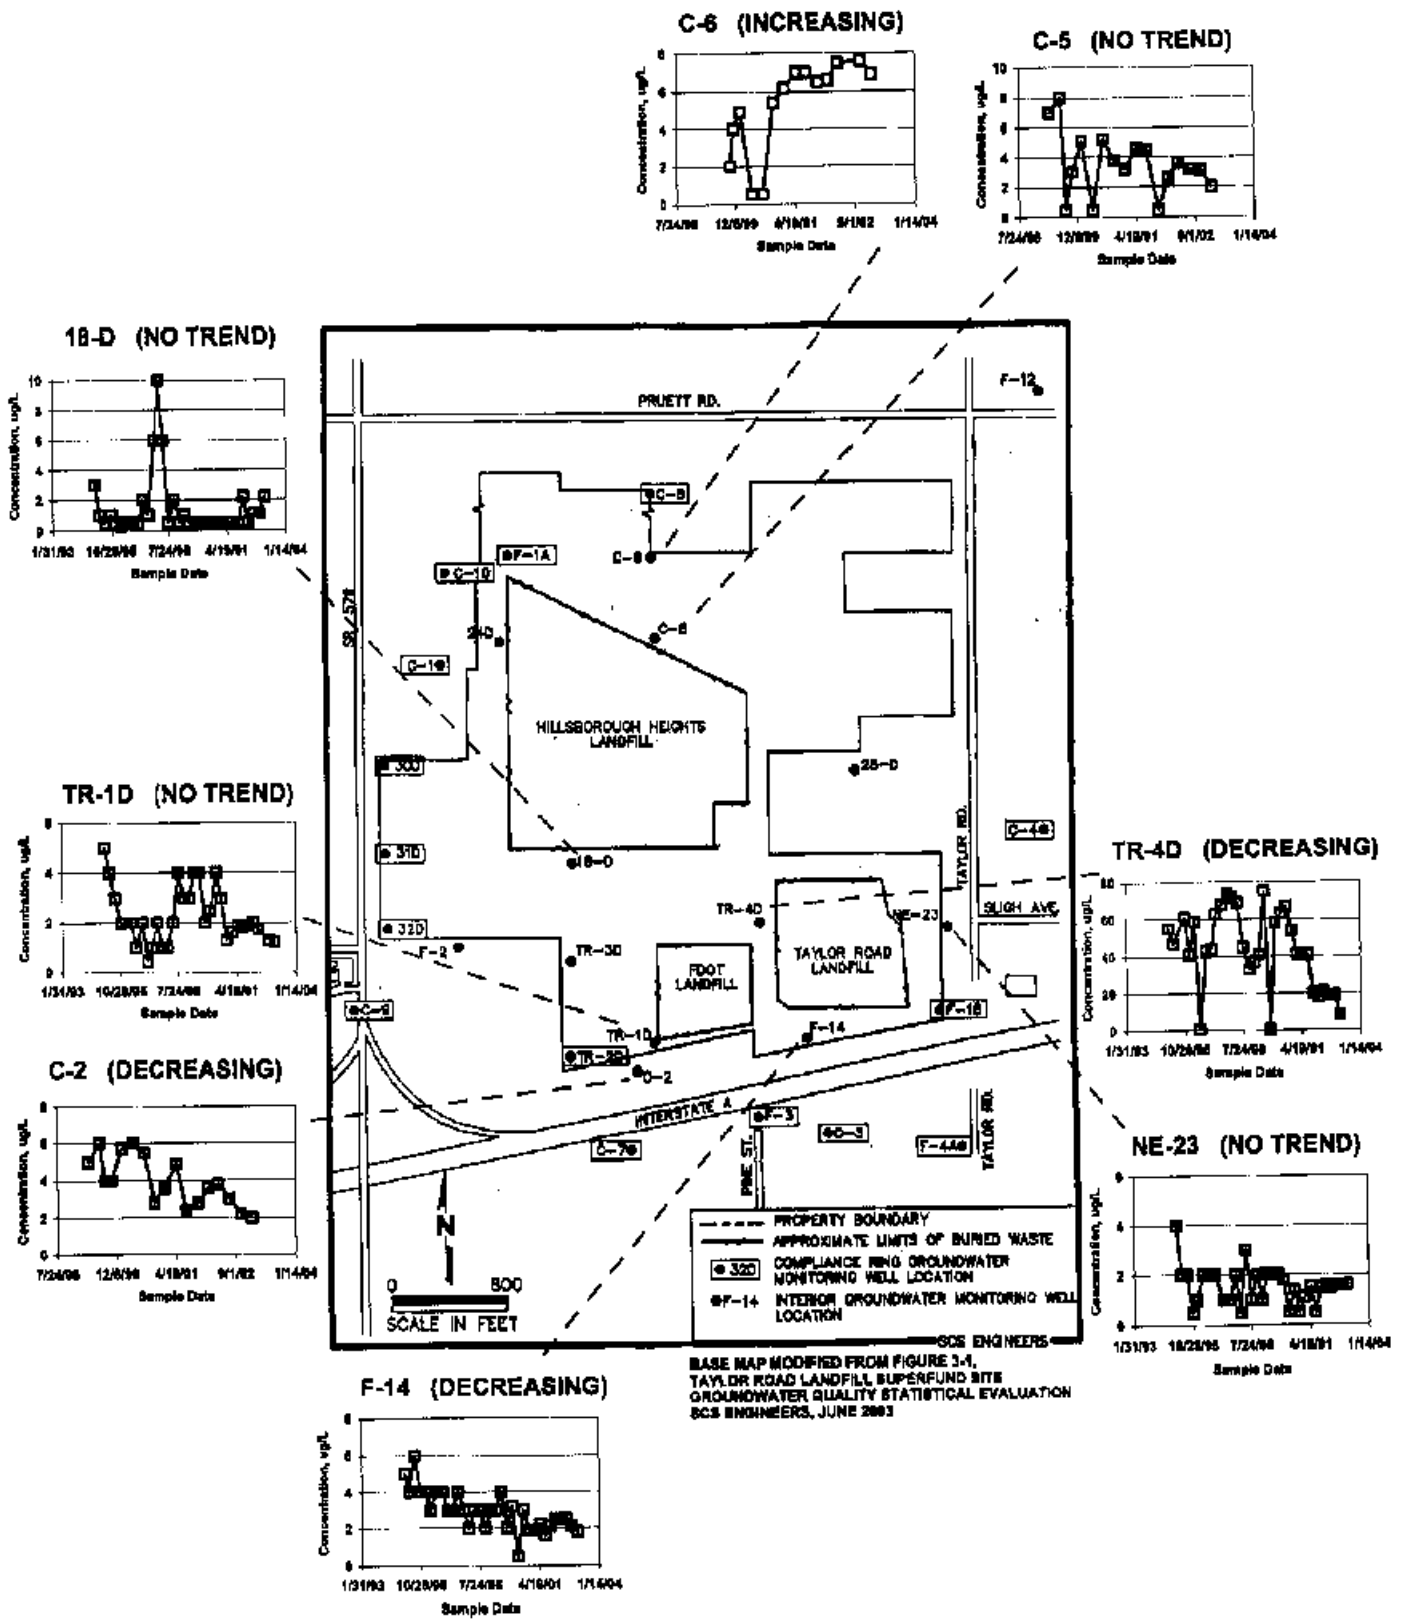
Figure 2. Trichloroethene Concentration Trends

Trichloroethene trends are shown on Figure 2 (Attachment 1). Figure 2 shows time-concentration plots for all wells where TCE has exceeded its 3 ug/L remediation level. This figure shows that for most of the monitoring wells where TCE has exceeded the remediation level, the concentrations are either decreasing, or showing no statistically significant trend. In the latter case, concentrations of TCE are close to the 3 ug/L standard. One well (C-6) is showing a statistically significant increase in the TCE concentration for the period of record, although the most recent samples from this well suggest that the concentrations of TCE at this well have stabilized. TCE is not a concern at any compliance monitoring well.

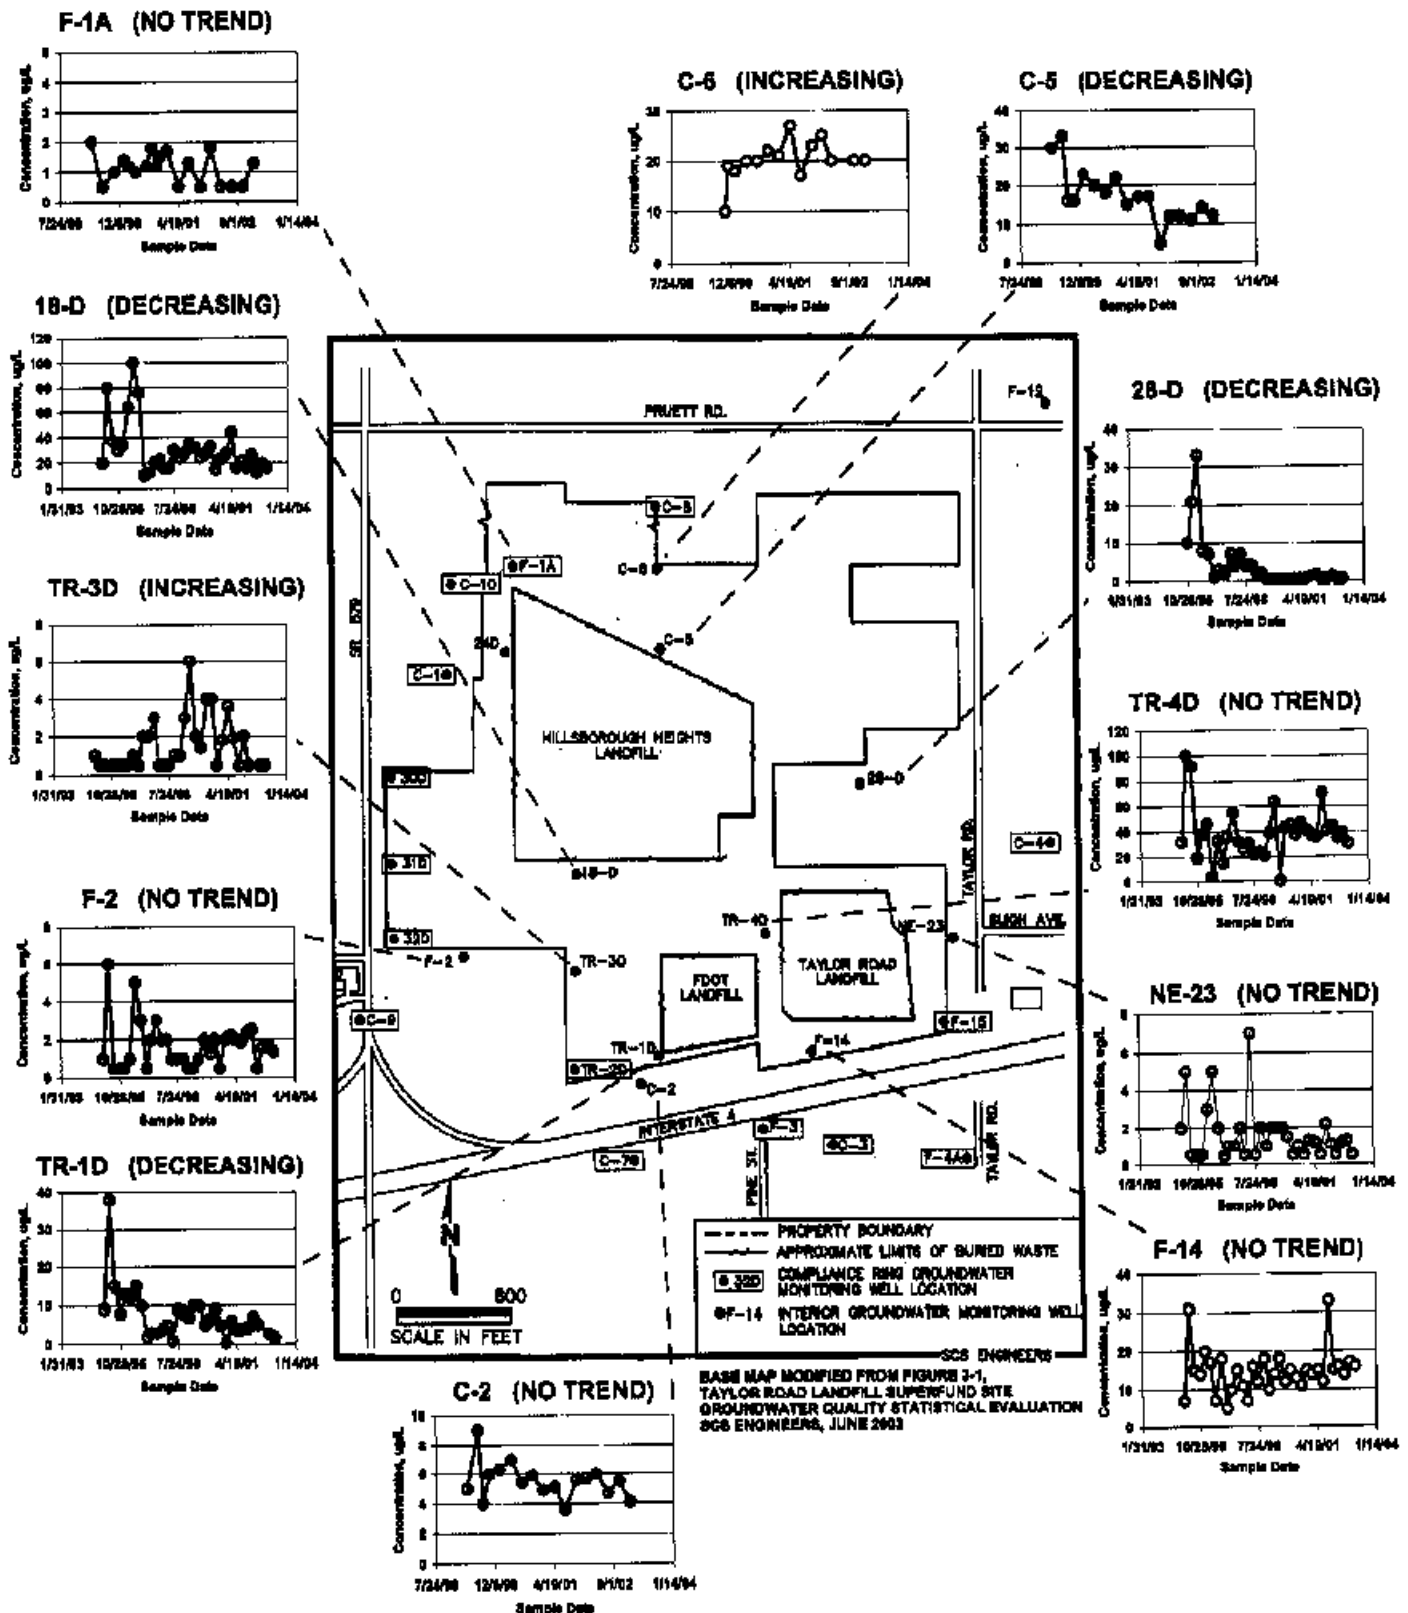
Figure 4. Vinyl Chloride Concentration Trends

Figure 4 shows the vinyl chloride concentration trends. Most of the wells show either decreasing concentrations over time or show no trend and have vinyl chloride concentrations of less than 10 ug/L. Most of the wells that have had very high vinyl chloride concentrations have had recent concentrations of vinyl chloride that are much lower. Vinyl chloride is not a concern at any compliance monitoring well.

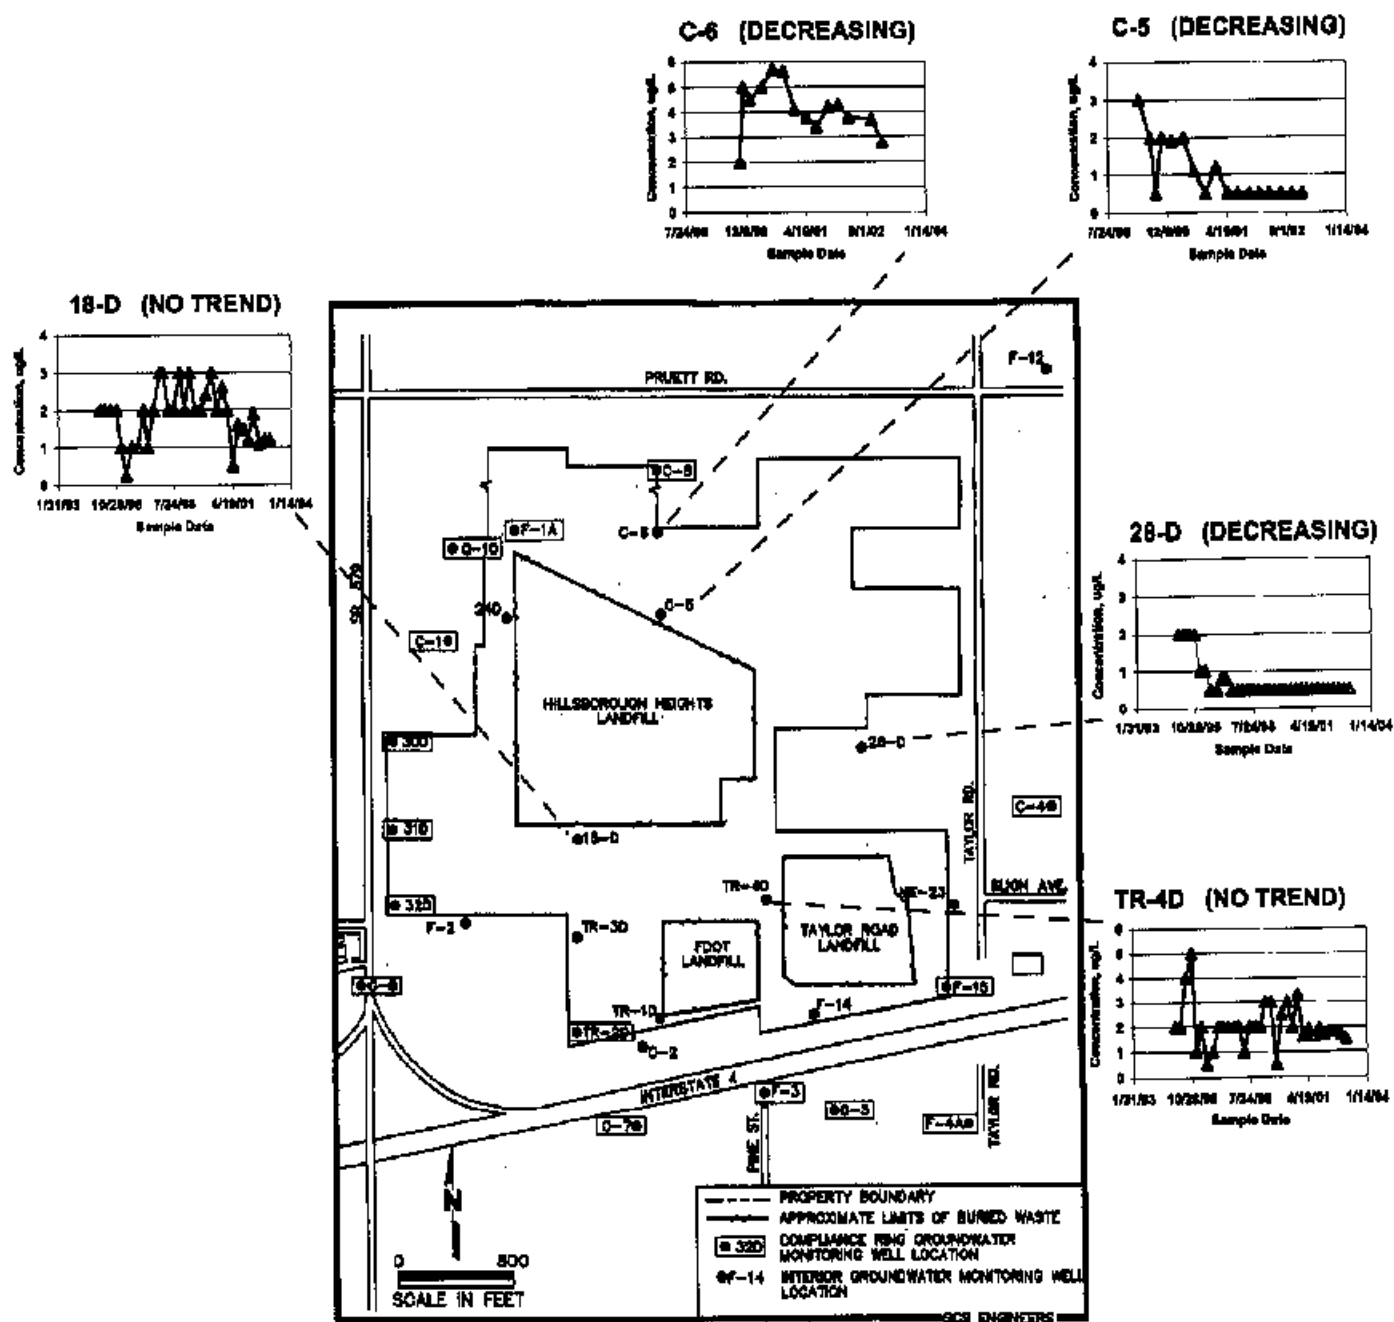
Figure 6. Benzene Concentration Trends

Figure 6 shows benzene concentration trends. This contaminant is showing either no trend or a decreasing concentration trend. Recent benzene concentrations are either close to or less than the 1 ug/L remediation level in all site monitoring wells.
